FRC ON-SITE AIR BAG DEPLOYMENT INVESTIGATION

CASE NO. 90-1

FLEET - 1990 SAAB 900S

Contract No. DTNH22-87-C-07169

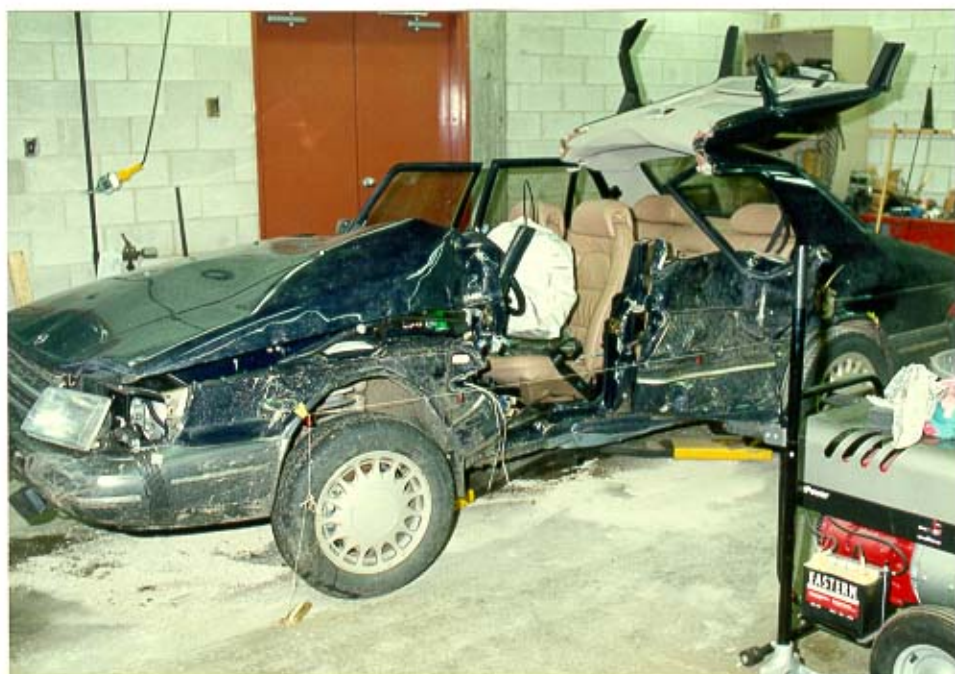
Left Side Damage To The 1990 Saab 900S.

<u>Air Bag Vehicle</u>	<u>Vehicle #2</u>
Exterior:	<p>Primary - The left side area of the air bag equipped Saab 900S sustained moderately severe damage from its impact with the left side area of vehicle #2. Maximum crush was 14.25" located on the sill 10" forward of the left B-pillar. Direct contact damage began 4" forward of the left rear axle position and extended 97.3" forward. The combined induced and direct contact damage began 6.5" rearward of the axle location and extended 111.25" forward.</p> <p>Rescue personnel removed the left front door and forced the left rear door open. They also cut the upper A- and B-pillars and pulled the roof rearward to aid the occupants of the vehicle. The crush profile at the mid door level was altered; therefore crush values at C<sub>2</sub> and C<sub>4</sub> were estimated at this level and measured at the sill where applicable. Crush values at door level were as follows: C<sub>1</sub>=0", C<sub>2</sub>=11.5", C<sub>3</sub>=6", C<sub>4</sub>=14.25", C<sub>5</sub>=5", C<sub>6</sub>=0". Sill displacement was 3.6" at C<sub>2</sub>, 9" at C<sub>3</sub>, and 8" at C<sub>4</sub>.</p>	<p>The left side of vehicle #2 sustained moderate overlapping damage from its impacts with the mailboxes and the air bag vehicle. Maximum crush was 11.25" located at the left front fender 7.5" forward of the axle position. The mailbox impacts were located on the left front fender 8.5" forward of the axle and 16" forward of the referenced axle position.</p> <p>The overlapping left side damage from the vehicle's impact with the Saab began 29.5" forward of the left rear axle and extended 111.5" forward to the left front corner.</p> <p>Crush values at mid-door level were as follows: C<sub>1</sub>=0", C<sub>2</sub>=3.9", C<sub>3</sub>=6.25", C<sub>4</sub>=5.5", C<sub>5</sub>=10.4", C<sub>6</sub>=5.9"</p> <p>As the vehicles crushed to maximum engagement, the left front corner area of the</p>

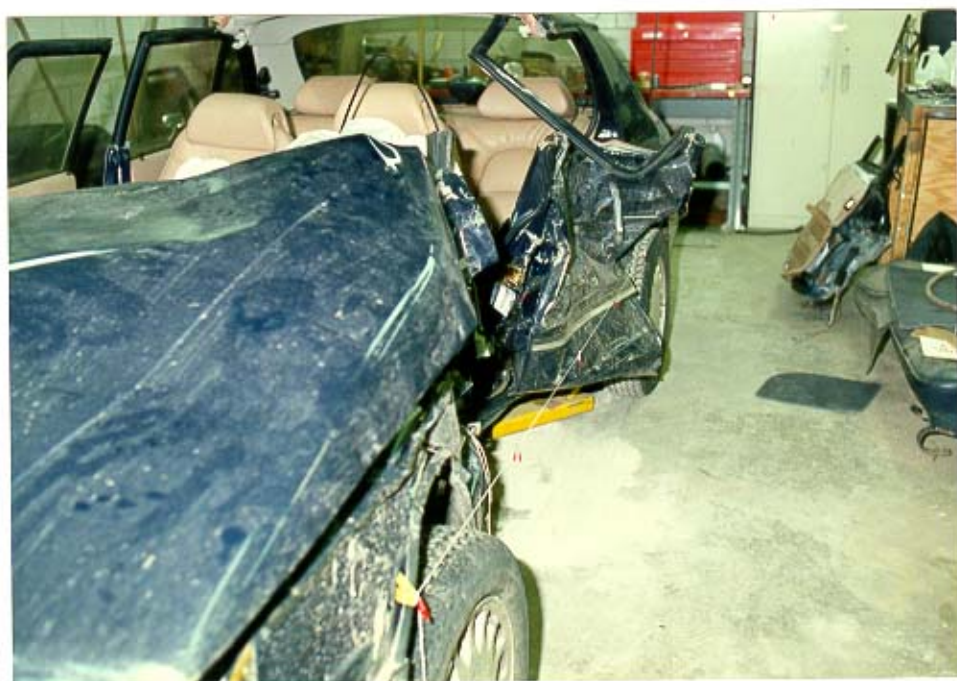
Longitudinal View Of The Damage Showing The Extent Of Crush.

Damaged components included the left front fender, hood, left front and rear doors, left A-, B-, and C-pillar, and the sill. The left wheelbase was reduced by 3.2" while the right side was elongated by 1.2".

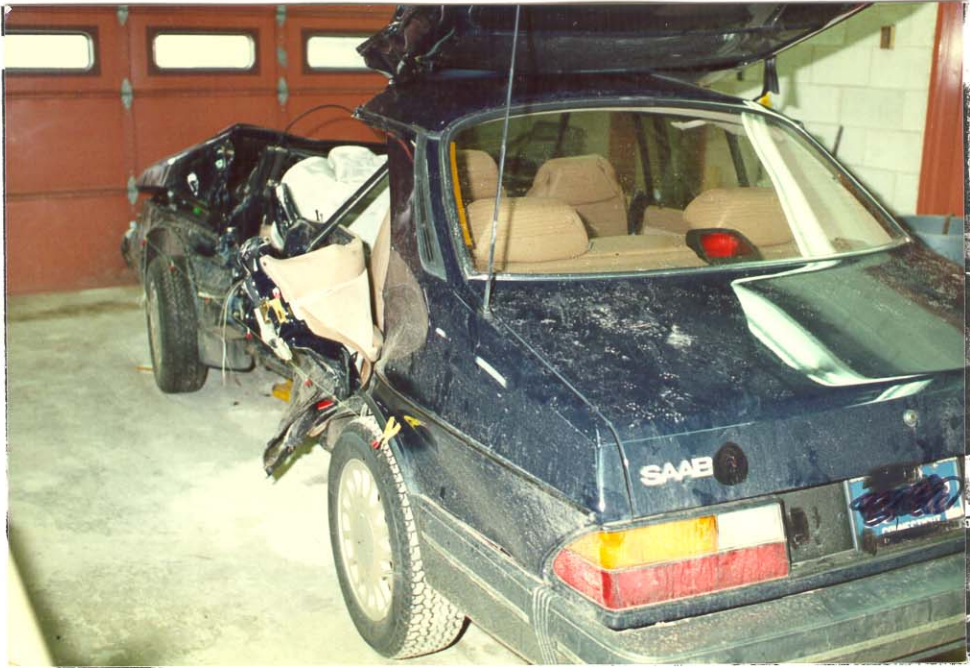
Left Rear Three-Quarter View Of The Saab.

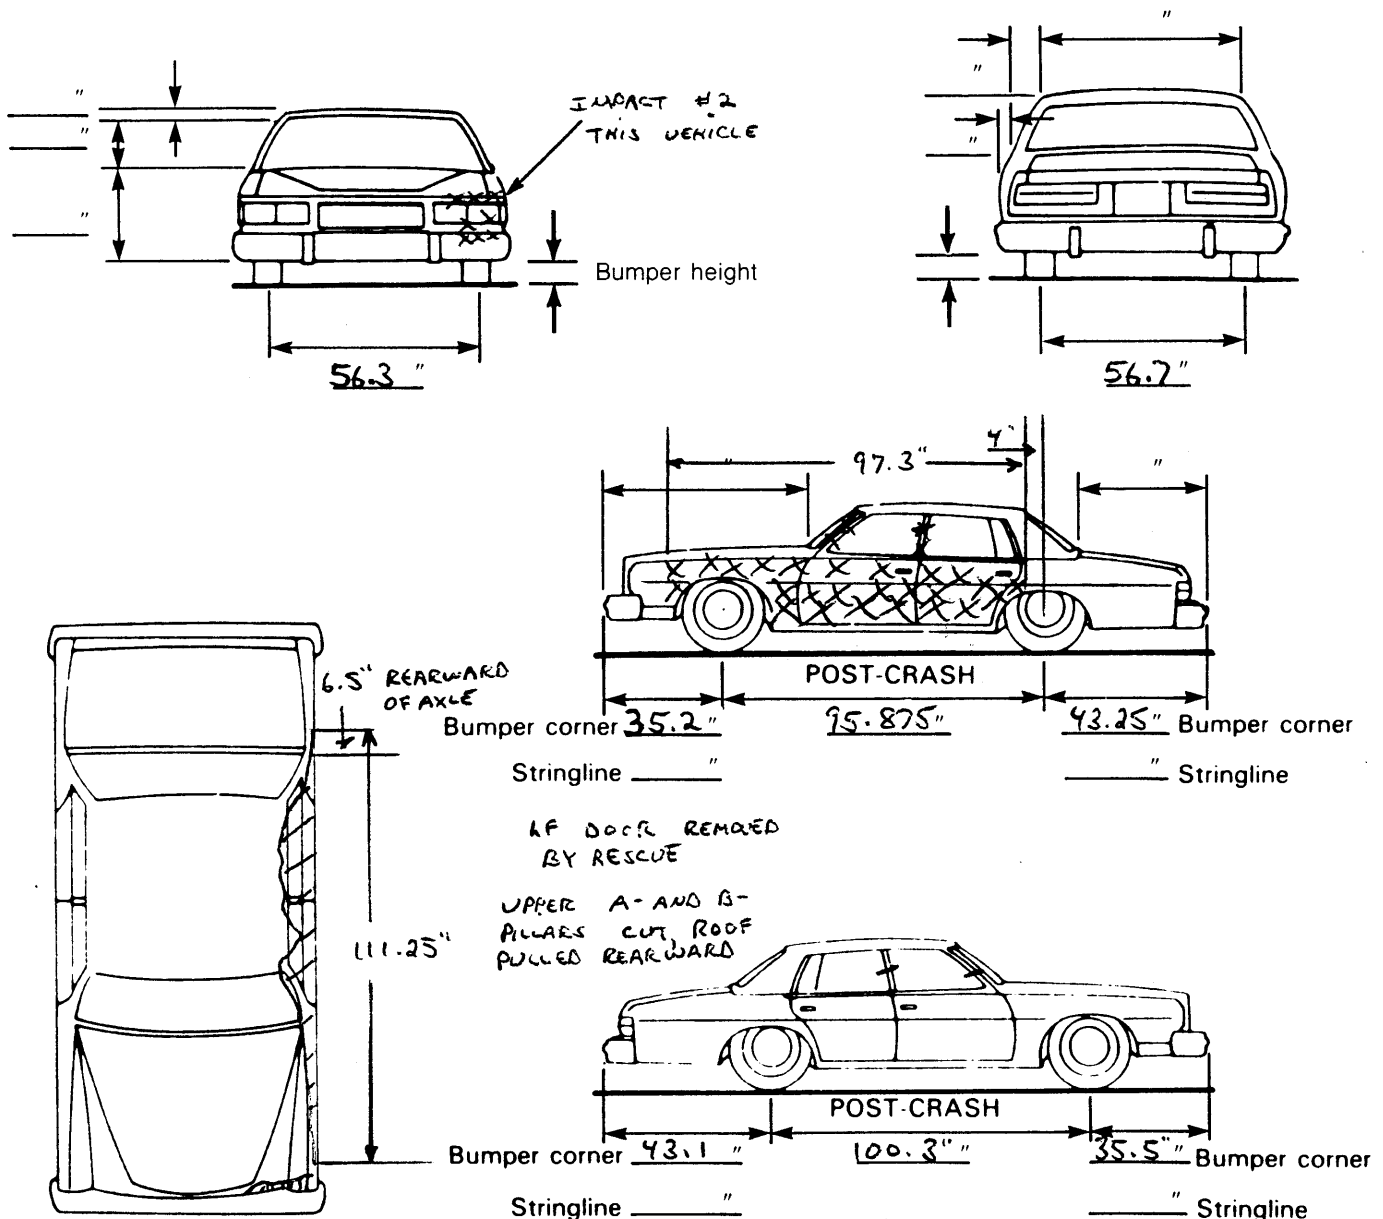
## VEHICLE DAMAGE SKETCH

Specific Impact No.	Location of Direct Damage	Location of Field L
1	LEFT SIDE 92.3" STARTS 4" FORWARD OF LR AXLE	111.25" STARTS 6.5" REARWARD OF LR AXLE
2	LEFT FRONT CORNER STARTS 15.1 - 27.5"	SAME AS DIRECT

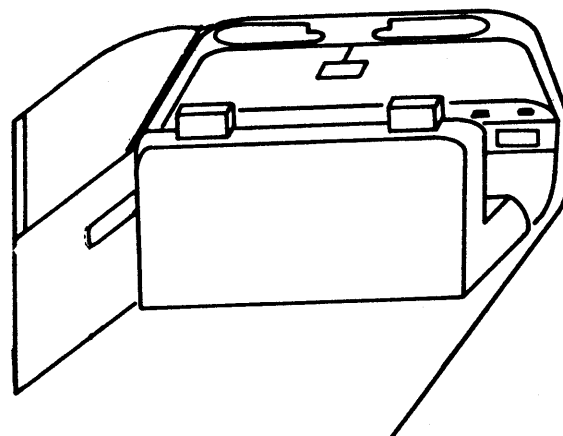
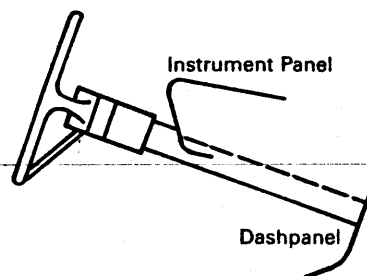
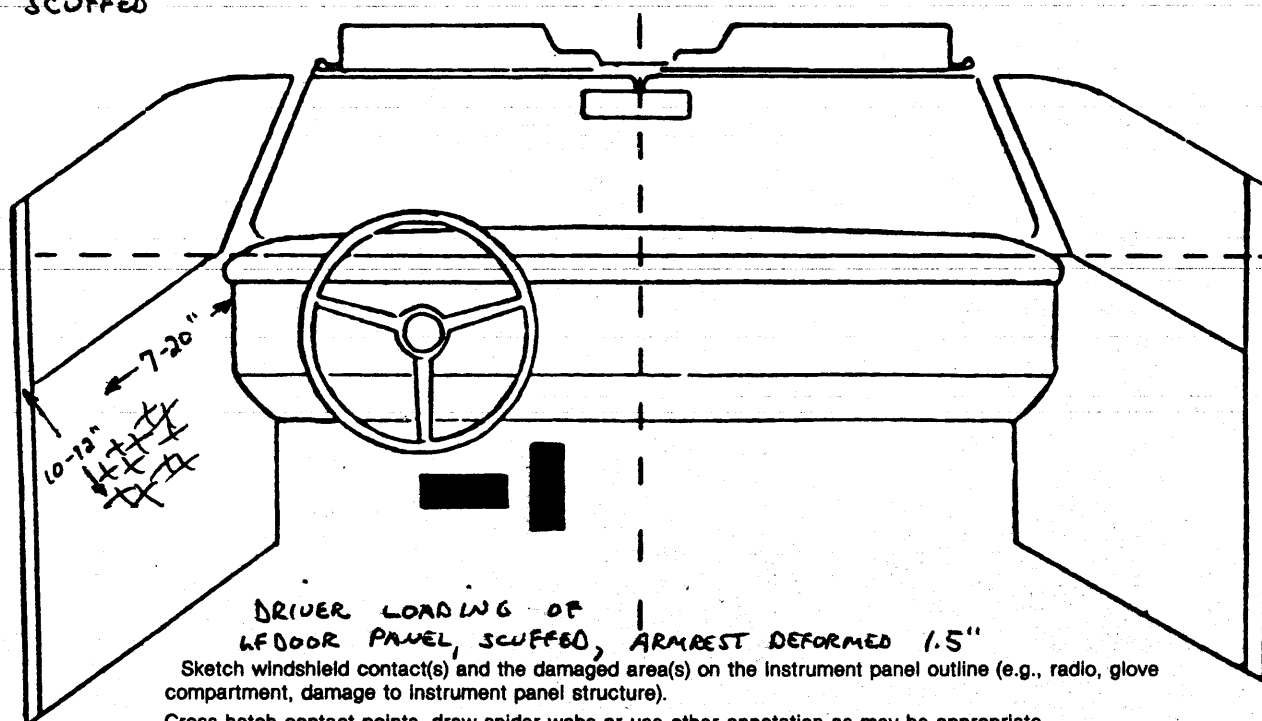
LEFT, REAR OCCUPANT  
LOADING OF THE LEFT  
DOOR PANEL AND ARMREST,  
SCUFFED

DRIVER LOADING OF  
LF DOOR PANEL, SCUFFED, ARMREST DEFORMED 1.5"  
Sketch windshield contact(s) and the damaged area(s) on the instrument panel outline (e.g., radio, glove  
compartment, damage to instrument panel structure).  
Cross hatch contact points, draw spider webs or use other annotation as may be appropriate.  
Annotate the contacted area with a letter (begin with A) and list on the Points of Occupant Contact page.
